Project: Leeds City Council
 Title: Leeds Footpath No.60 Ch
 Drawn: CAU
 Scale: AS SHOWN
 Date: 05.11.17
 Drawing Number: LD.634.02

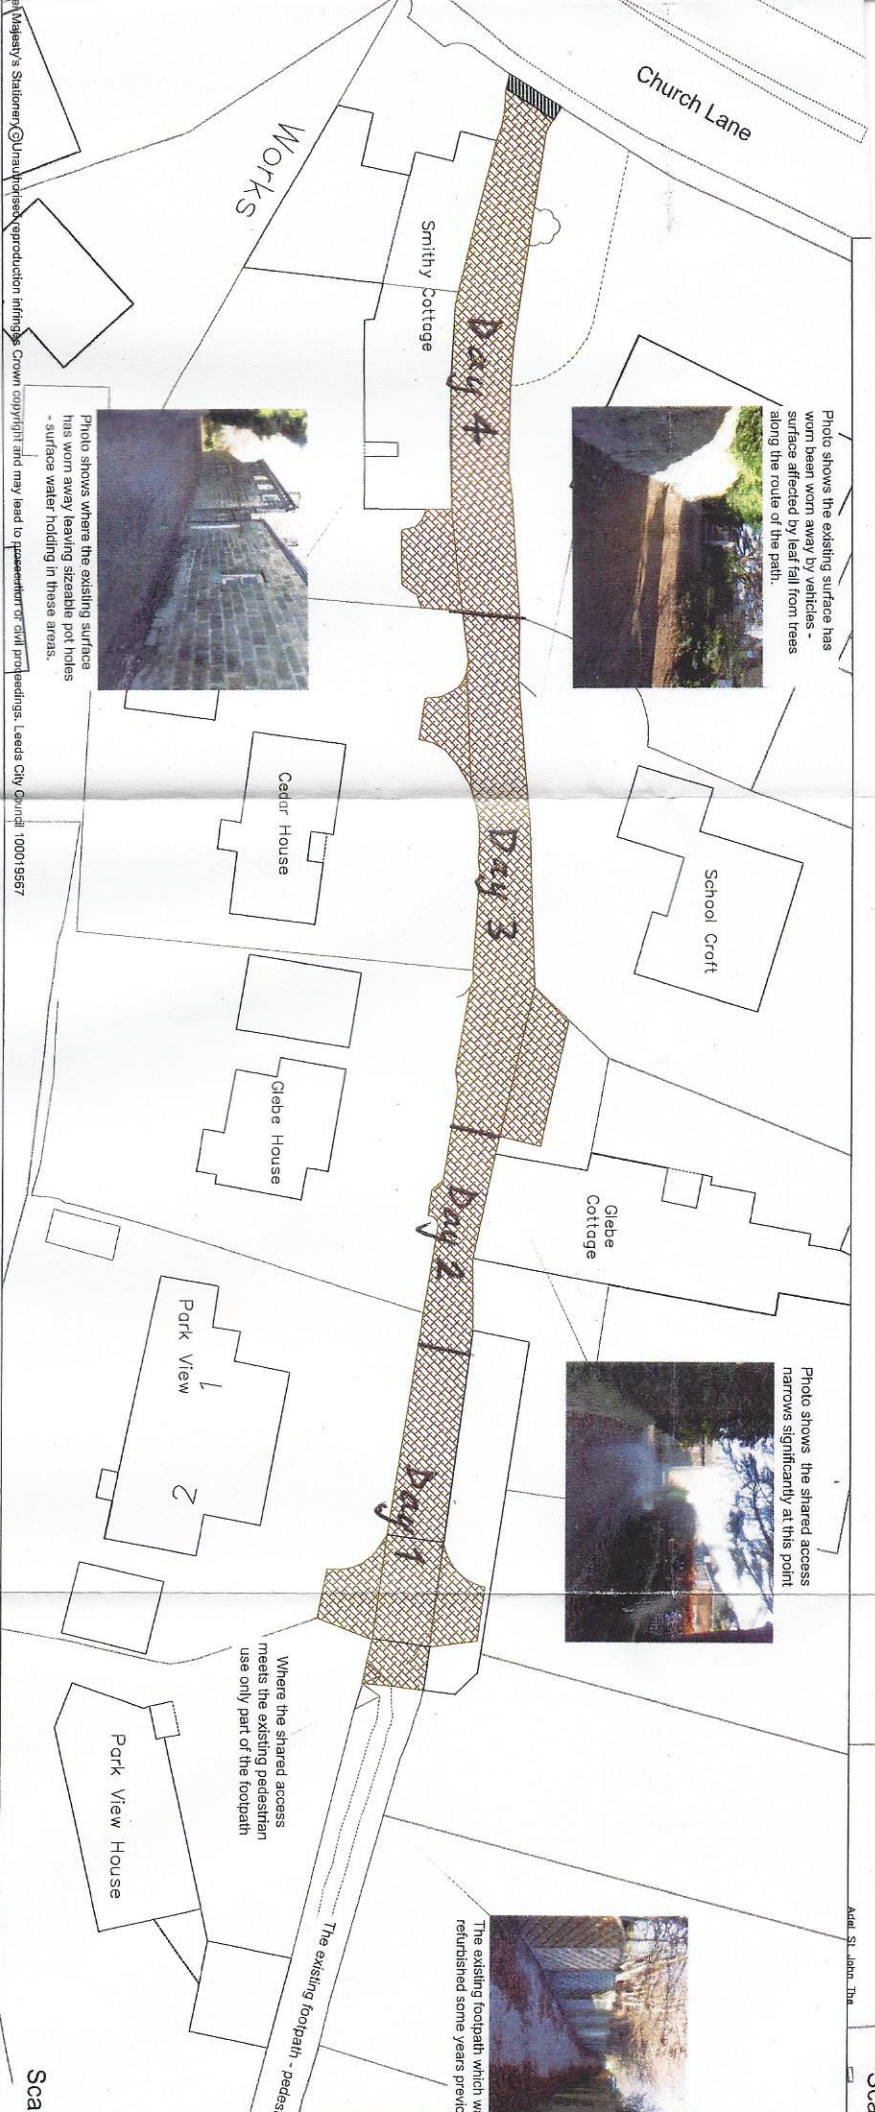
Photo shows the existing surface has worn been worn away by vehicles - surface affected by leaf fall from trees along the route of the path.

Photo shows the shared access narrows significantly at this point

The existing footpath which was refurbished some years previous

Photo shows where the existing surface has worn away leaving sizeable potholes - surface water holding in these areas.

Where the shared access meets the existing pedestrian use only part of the footpath

Area to be resurfaced with 'Flexi-Pave' (including additional links to private properties)

N.B. To be done in 4 day sections as shown.
